Quality Assurance and Source Inspection

Contract #: 04-0120F4Cty: SF/ALA Rte: 80 PM: 13.2/13.9File #: 69.28**WELDING INSPECTION REPORT****Resident Engineer:**Siegenthaler, Peter**Address:** 333 Burma Road**City:** Oakland, CA 94607**Report No:** WIR-025640**Date Inspected:** 04-Aug-2011**Project Name:** SAS Superstructure**OSM Arrival Time:** 700**Prime Contractor:** American Bridge/Fluor Enterprises, a JV**OSM Departure Time:** 1900**Contractor:** Zhenhua Port Machinery Company, Ltd (ZPMC), Changxing Island **Location:** Shanghai, China**CWI Name:** An Qing Xiang**CWI Present:** Yes No**Inspected CWI report:** Yes No N/A**Rod Oven in Use:** Yes No N/A**Electrode to specification:** Yes No N/A**Weld Procedures Followed:** Yes No N/A**Qualified Welders:** Yes No N/A**Verified Joint Fit-up:** Yes No N/A**Approved Drawings:** Yes No N/A**Approved WPS:** Yes No N/A**Delayed / Cancelled:** Yes No N/A**Bridge No:** 34-0006**Component:** OBG**Summary of Items Observed:**

SHIP # 19, OBG SEGMENT 14E

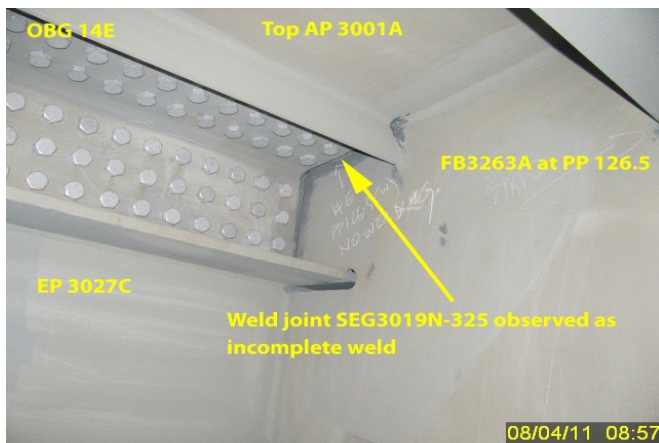
Weld joint SEG3019N-325 joining top Anchorage Plate (AP) 3001A to Floor Beam (FB) 3263A at Panel Point (PP) 126.5 (W) observed as incomplete weld.

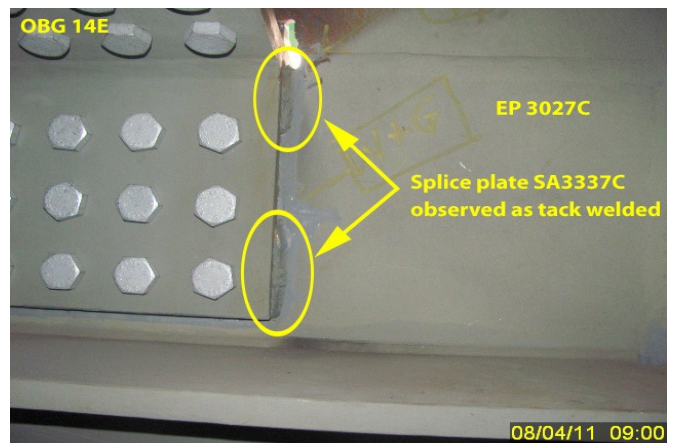
Splice plates SA3337C in between PP 126 to PP 127 observed as tack welded with Edge Panel (EP) 3027C.
